Marine Corrosion Studies

The Effects of Dissimilar Metal Couples and Toxicants from Antifouling Paints on the Corrosion of 5086 and 6061 Aluminum Alloys and Their Response to Cathodic Protection

(Fourteenth Interim Report of Progress)

T. J. LENNOX, JR., M. H. PETERSON, J. A. SMITH,
AND R. E. GROOVER

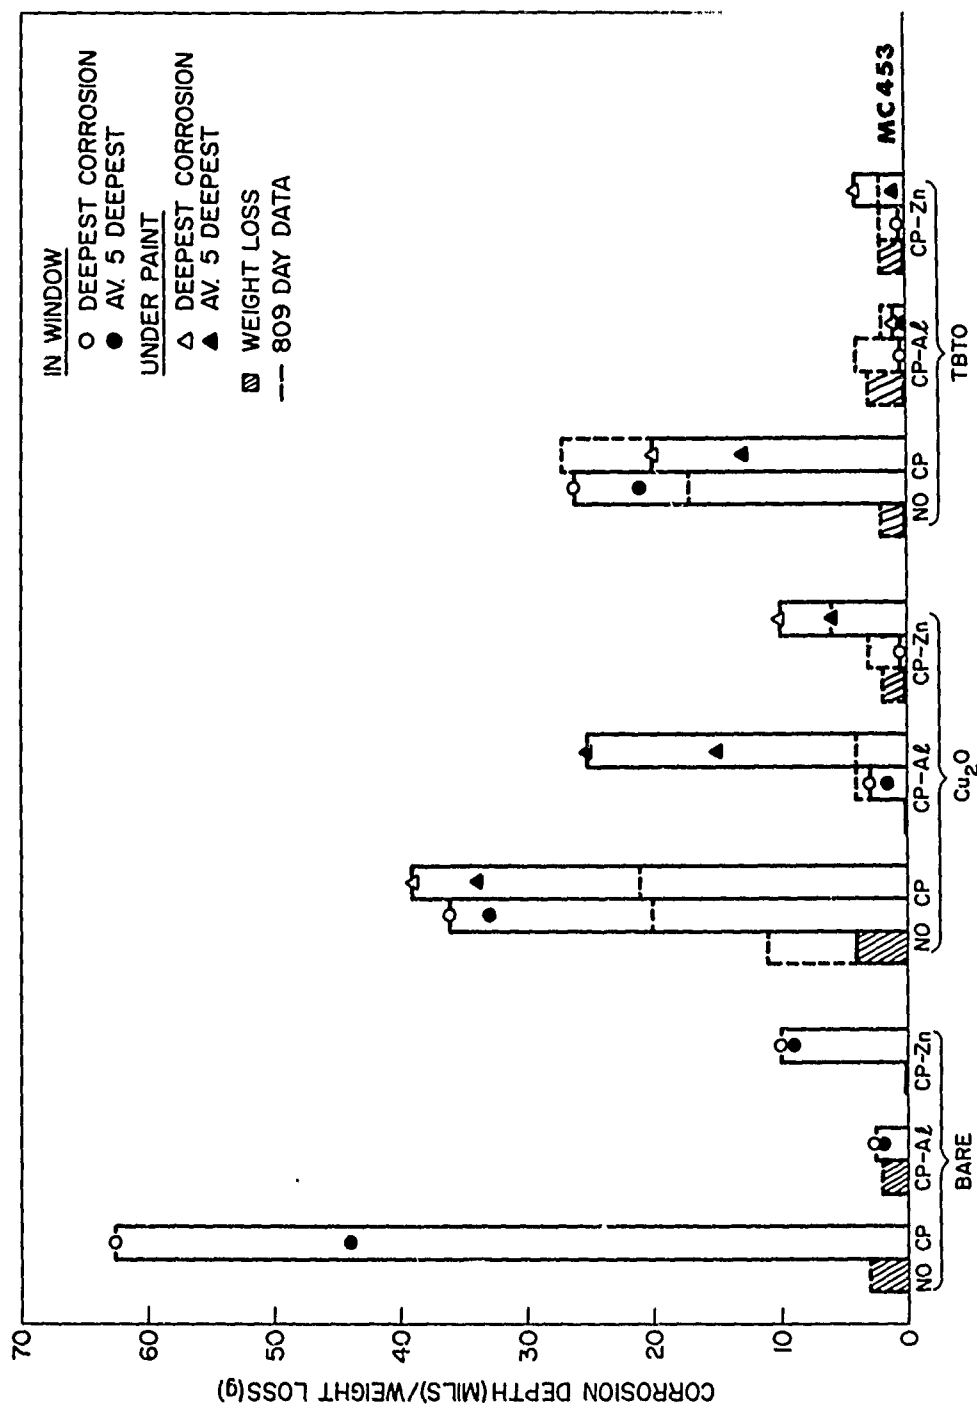
Fig. 57 - 6061-T6 aluminum coated with the Standard Navy Vinyl Anticorrosive Barrier and Cu₂O or TBTO Antifouling Toxicants; with and without cathodic protection (CP), 1264 days in seawater at Key West, Florida.

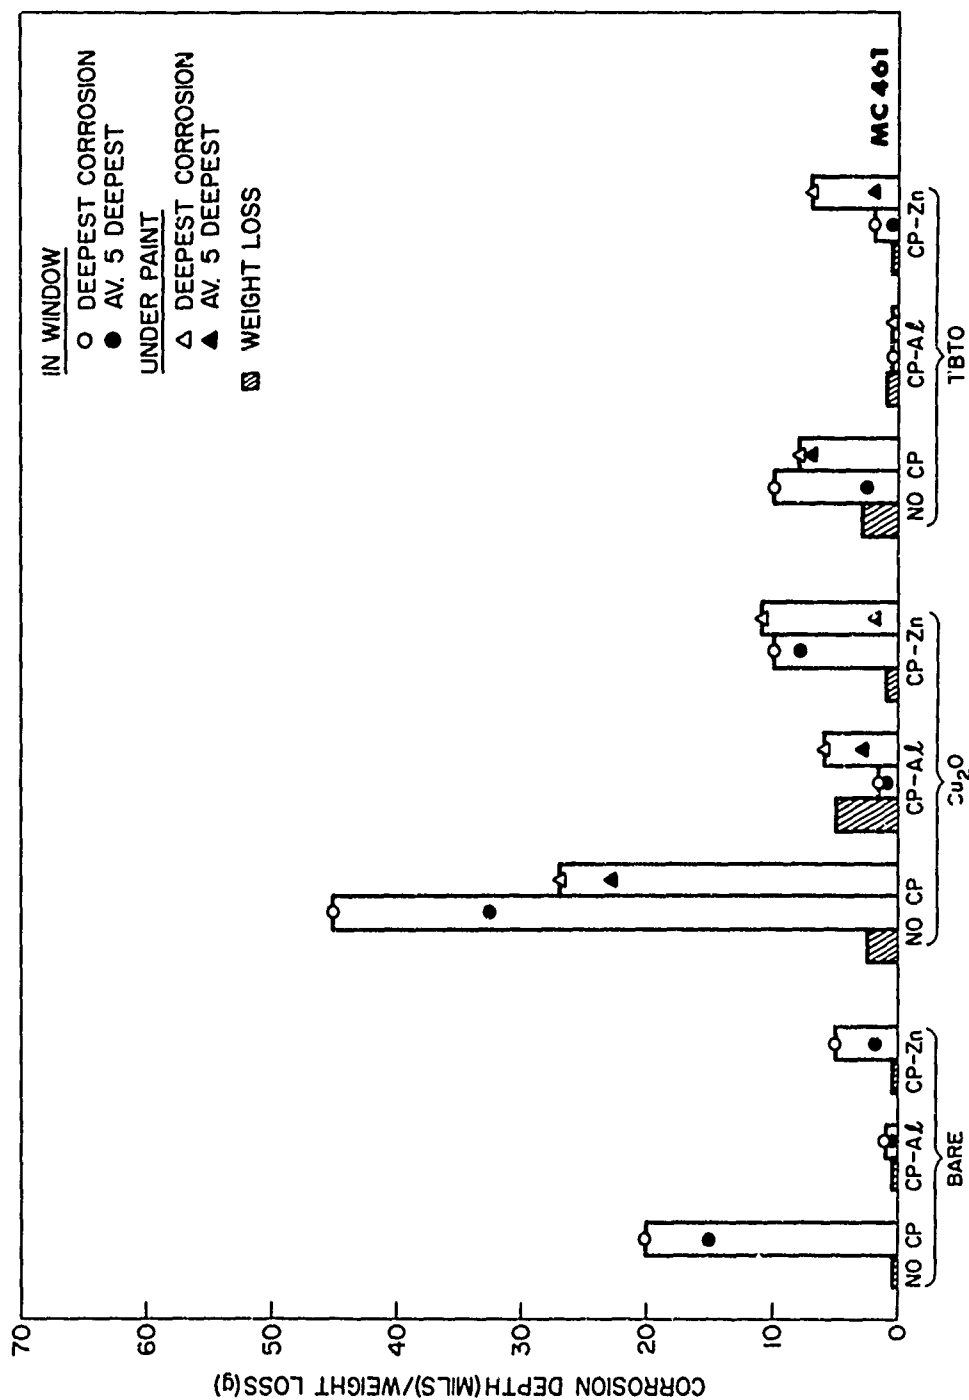
The data for the depth of corrosion and response to cathodic protection at the bared window areas and under the paint on the 6061-T6 aluminum exposed for 675 days in the Potomac River are summarized in Fig. 60. Uncoated and unprotected 6061-T6 aluminum corroded to a depth of 20 mils. The data in Fig. 60 and the photograph in Fig. 61 show that the Cu_2O antifouling paint increased the depth of corrosion.

Fig. 60 - 6061T6 aluminum coated with the Standard Navy Vinyl Anticorrosive Barrier and Cu_2O or TBTO Antifouling Toxicants; with and without cathodic protection (CP), 675 days in the Potomac River.
